## Mass Carbon Monoxide Poisoning on a Train in Italy, March 1944. History Reconstructed

**Hampson NB. Mass Carbon Monoxide Poisoning on a Train in Italy, March 1944. History Reconstructed. Undersea Hyperb Med. 2024 Third Quarter; 51(3):247-251.**

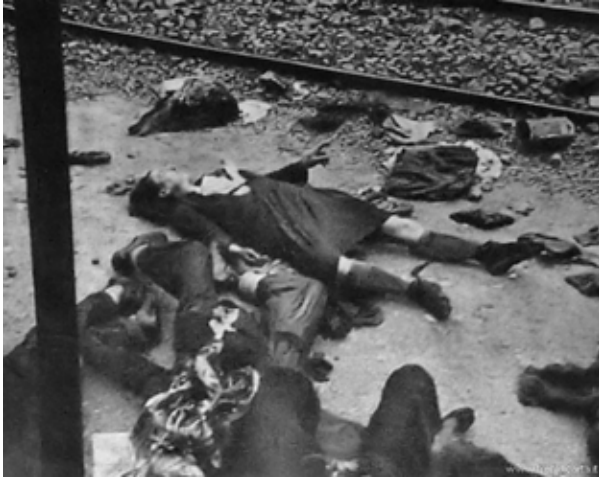
**Figure 4.** Dead passenger bodies alongside railway tracks. (Source of photograph reference 7, in public domain)

The search party from Balvano arrived at the site four hours after the 8017 entered the Galleria delle Armi. They were unable to immediately pull the train from the tunnel due to the large number of corpses on the tracks and under the train (Figure 4). Bodies were found inside and outside the train. A few were alive. In the end, there were about forty survivors. Of the crew, the second brakeman from the caboose and the fireman of the second locomotive were the only survivors. The head engineer was found dead in his seat, hands still on the controls.

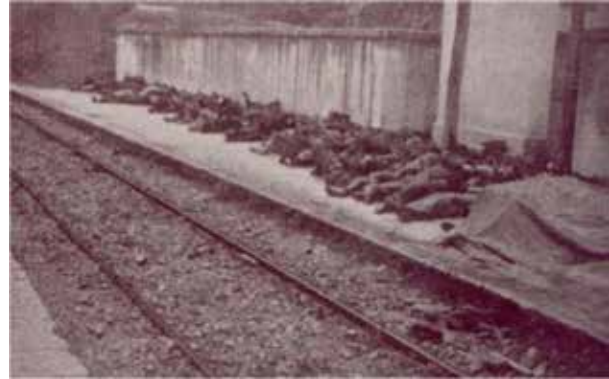
**Figure 5.** Bodies of people killed by carbon monoxide poisoning stacked on platform in Balvano train station. (Source of photograph reference 7, in public domain)

from the train by police and military personnel and stacked on the station platforms (Figure 5). In all, there were 521 deaths from carbon monoxide poisoning. Many carried false papers or no identification at all, leading to the inability to identify 193 of the deceased. Due to the large number of bodies, the wartime lack of resources, the inability to identify many of the dead, and the poverty of many victims, they were hastily buried in a mass grave in the Balvano cemetery (Figure 6). Only the railroad crew received proper burials.
